# NEWSLETTER

## Ice Damming, what is it?

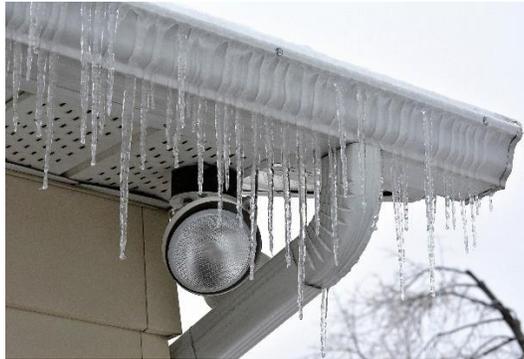
During our home inspections, sometimes we see signs of water leaks in the ceiling where the ceiling meets the roof. This is usually caused by “Ice Damming”. Ice damming is caused by snow melting on the roof and then dripping down towards the gutters where it freezes again and builds up ice and a little “pond” forms on the lower portion of the roof and gutters. The pond gets bigger as more and more snow melts and then freezes down by the gutter. Eventually, the water backs up under the roof shingles which causes the leaks.

What makes this happen? The attic is too warm, thereby causing the snow to melt on the roof. If you do have this problem, we recommend that you deal with it because it can cause wood rot and mold above the ceiling and inside the wall. It can also attract wood-destroying insects like termites.

Because your attic is too warm, you have an opportunity to save energy while fixing the ice damming issue. The first approach to fixing the problem is to stop warm air from getting into your attic. That means sealing openings between your attic and the living space. This may require additional insulation and/or blocking any openings between the living space and the attic, such as openings around electrical wires, high-hat light fixtures, plumbing pipes, dryer, and bathroom vents. By the way, sometimes bathroom vent fans and clothing dryers discharge warm air directly into the attic. Ideally, the attic temperature should be similar to the exterior temperature.
